**Flood Control Project Maintenance
Levee Inspections**

Fall 2018 Levee Maintenance Deficiency Summary Report

Sacramento River Basin

**Flood Control Project Maintenance
Levee Inspections****LMA District Cover Sheet****Fall 2018 Levee Inspection Results****Reclamation District No. 2035 Conaway**

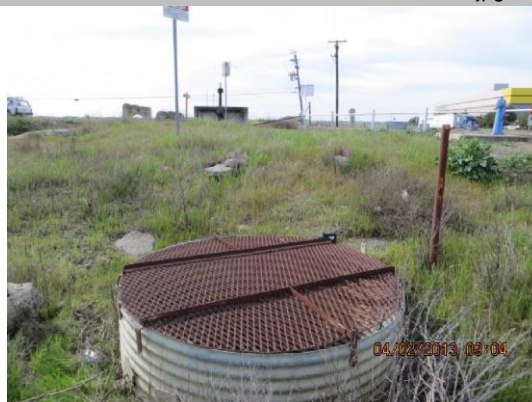
Photo 2 of 3 : UCIP_FA_2018_41346_18101.jpg

Comment Code						
Inspector Comment						
FS_ID:41346 DS_ID:17819 EP_NO: 4363 Repair Type: Non-Urgent Crossing Status: Found UCIP Comments: 04/02/2013 This pipe appears abandoned and if so should be done so properly. (W. Wylie - DWR UCIP) FIELD_STRUCT_DESC: *ABANDONED* 36-inch corrugated metal drainage pipe through the levee, 7.8 feet below the crown. 30-inch welded steel pipe sleeved through the 36-inch corrugated metal pipe (CMP) with annular space grouted. Flap gate in 72-inch corrugated metal pipe (CMP) riser at the waterside (WS) toe with abandoned pump platform on the south side of East Main Street. (Permit No. 4363, 1963 - City of Woodland, City Engineer). [Additional Reference(s): DWR Levee Log, 1990]. FS Date: 4/2/2013 3:09:00 PM

72-inch CMP riser on WS toe.

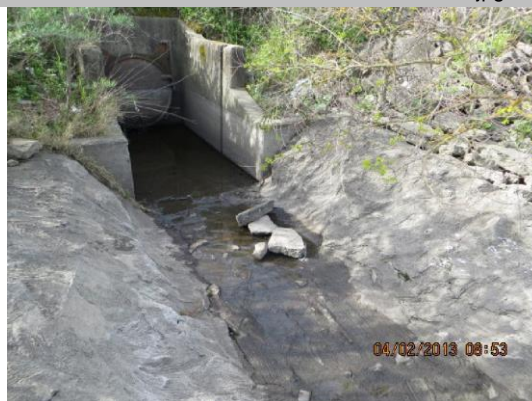
Photo 2 of 3 : UCIP_FA_2018_10827_18108.jpg

Comment Code						
Inspector Comment						
FS_ID:10827 DS_ID:17814 EP_NO: 10127 Repair Type: No Action Needed Crossing Status: Found UCIP Comments: FIELD_STRUCT_DESC: 42-inch concrete encased corrugated metal drainage pipe through the levee, 10 feet below the crown. Flap gate on the waterside (WS) end. Grouted spillway on the WS. Pipe exposed on the landside (LS). (36-inch pipe [HLM 0.02] authorized under Automatic Board Order (ABO) issued as Permit No. 10127, 1974 - City of Woodland, Department of Public Works). [Additional Reference(s): DWR Levee Log, 1990. USACE Sacramento O&M Manual 126, November 1961, (HLM 0.01), listed as 5.5 feet below the crown]. FS Date: 4/2/2013

Flap gate and spillway on WS toe.

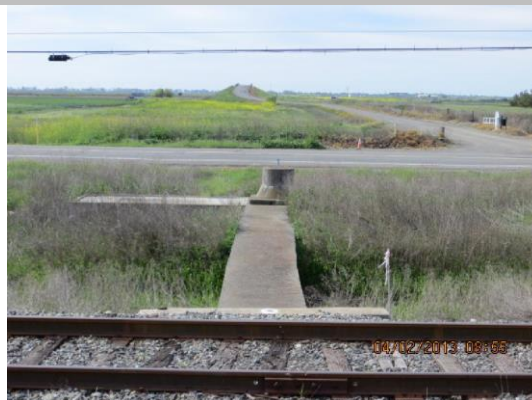
Photo 3 of 3 : UCIP_FA_2018_10827_18107.jpg

Concrete encased pipe on LS toe.

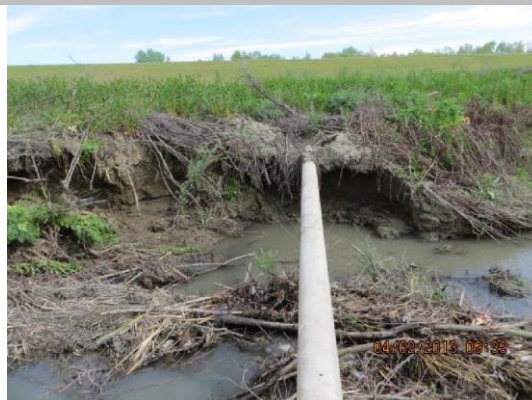
Photo 2 of 3 : UCIP_FA_2018_42012_18114.jpg

Comment Code						
Inspector Comment						
FS_ID:42012 DS_ID:17816 EP_NO: 12597 Repair Type: Non-Urgent Crossing Status: Found UCIP Comments: 04/02/2013 Pipe appears abandoned and if so should be done so properly. (W. Wylie - DWR UCIP) FIELD_STRUCT_DESC: *ABANDONED* 18-inch steel conductor pipe for floating silt dredge through the levee, 3.4 feet below the crown. 10-inch steel pipe sleeved through the 18-inch steel conductor pipe with annular space grouted. Siphon breaker on the waterside (WS) shoulder in steel riser. (Permit No. 12597, 1978 - Reclamation District No. 2035). [Additional Reference(s): DWR Levee Log, 1990]. FS Date: 4/2/2013

Exposed pipe at WS toe/stream.

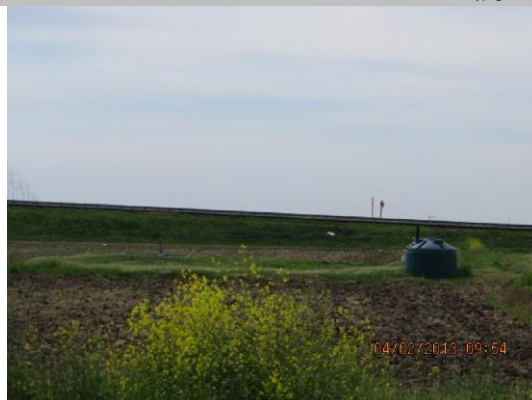
Photo 1 of 2 : UCIP_FA_2018_10913_18188.jpg

LM Start	1.87	Rating **	M	Issue No.	13
LM End	1.87	Issue Type +	En	Location *	
Category	Supplemental			GPS Latitude/Longitude	
				Start	End
Item	DWR UCIP Field Study			38.677186 °	38.677186 °
				-121.675277 °	-121.675277 °
DWR ID	17867				
Comment Code					
Inspector Comment					
FS_ID:10913 DS_ID:17867 EP_NO: 13201 Repair Type: Non-Urgent Crossing Status: Indicator Found UCIP Comments: 04/02/2013 Pipe needs to be properly marked or abandoned. (W. Wylie - DWR UCIP) FIELD_STRUCT_DESC: 8-inch casing of an unknown material through the levee, 25 feet below the crown. 3-inch gas line sleeved through the casing with annular space filled with bentonite. Possible vent for pipe on the landside (LS) next to Old River Road. (Permit No. 13201, 1981 - Pacific Gas and Electric Company [PG&E]). FS Date: 4/2/2013

Natural gas well on south side of Old river road.

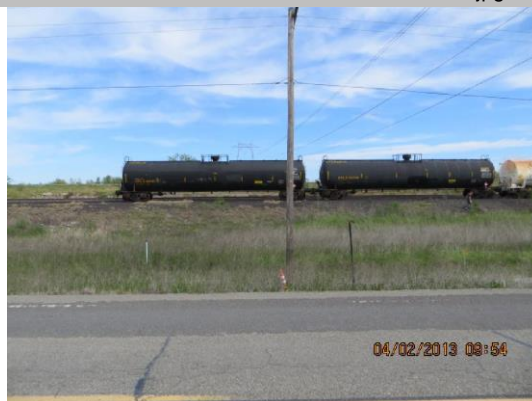
Photo 2 of 2 : UCIP_FA_2018_10913_18187.jpg

LM Start	1.87	Rating **	M	Issue No.	13 (cont)
LM End	1.87	Issue Type +	En	Location *	
Category	Supplemental			GPS Latitude/Longitude	
				Start	End
Item	DWR UCIP Field Study			38.677186 °	38.677186 °
				-121.675277 °	-121.675277 °
DWR ID	17867				
Comment Code					
Inspector Comment					
FS_ID:10913 DS_ID:17867 EP_NO: 13201 Repair Type: Non-Urgent Crossing Status: Indicator Found UCIP Comments: 04/02/2013 Pipe needs to be properly marked or abandoned. (W. Wylie - DWR UCIP) FIELD_STRUCT_DESC: 8-inch casing of an unknown material through the levee, 25 feet below the crown. 3-inch gas line sleeved through the casing with annular space filled with bentonite. Possible vent for pipe on the landside (LS) next to Old River Road. (Permit No. 13201, 1981 - Pacific Gas and Electric Company [PG&E]). FS Date: 4/2/2013

Vent pipe to right of JP next to Old River Road.

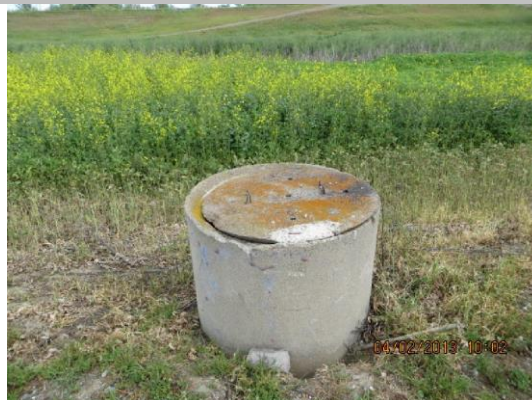
Photo 1 of 1 : UCIP_FA_2018_10914_18189.jpg

LM Start	1.94	Rating **	M	Issue No.	14
LM End	1.94	Issue Type +	En	Location *	
Category	Supplemental			GPS Latitude/Longitude	
				Start	End
Item	DWR UCIP Field Study			38.677175 °	38.677175 °
				-121.674065 °	-121.674065 °
DWR ID	17817				
Comment Code					
Inspector Comment					
FS_ID:10914 DS_ID:17817 EP_NO: 2544 Repair Type: Non-Urgent Crossing Status: Found UCIP Comments: 04/02/2013 Pipe appears to be abandoned as there is no pumphouse. Needs to be abandoned properly (W. Wylie - DWR UCIP) FIELD_STRUCT_DESC: 16-inch steel drainage pipe through the levee, 5 feet below the crown. Pump on piling structure in drainage ditch on the landside (LS). 36-inch concrete standpipe on the waterside (WS) shoulder. (Permit No. 2544, 1957 - City of Woodland). [Additional Reference(s): DWR Levee Log, 1990]. FS Date: 4/2/2013

36-inch Concrete stand pipe on WS shoulder.

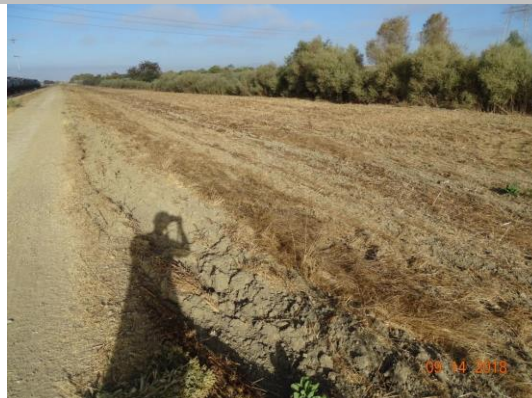
Photo 1 of 1 : FA_2018_RD2035_238_9_20180914_00013.jpg

View of the mowed waterside slope, facing upstream. Fall 2018.

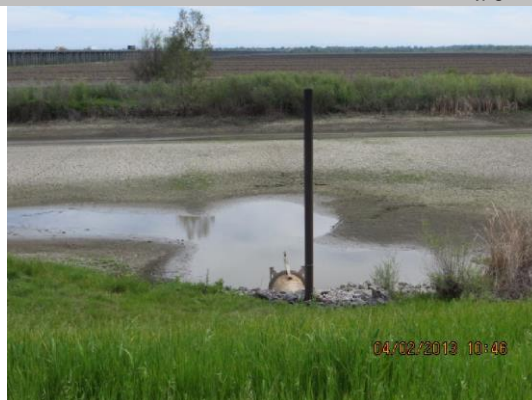
Photo 2 of 3 : UCIP_FA_2018_53429_18201.jpg

Comment Code					
Inspector Comment					
FS_ID:53429 DS_ID:17822 EP_NO: N/A Repair Type: Urgent Crossing Status: Found UCIP Comments: 10/30/2018 Same as last inspection. Flap gate on the WS was submerged at the time of the inspection. Erosion is still present behind the headwall. Sink hole/burrow activity was observed along the concrete box located on the LS. Recommend internal inspection of the pipe section through levee to determine the condition of the pipe through the levee. Crossing remains Urgent due to signs of pipe leakage on LS. (O. Magana - DWR UCIP)09/14/2016 - Flap gate on the WS was submerged at time of inspection. LS headwall at the pumping plant has exposed rebar. There is still erosion present behind the headwall. However, water was present making it difficult to determine if it is getting worse. As-built drawings were requested from LMA consultant representative. (T. Hatch/UCIP)04/02/2013 - Flap gate broken in half on WS toe. Some erosion at headwalls on pumping plant. (W. Wylie/UCIP) FIELD_STRUCT_DESC: 44-inch corrugated metal drainage pipe through the levee, 22 feet below the crown. Pump on platform in drainage ditch at the landside (LS) toe. Slide gate and flap gates in a 5-foot by 9-foot concrete box. Flap gate on the waterside (WS) toe. 8-inch vent/standpipe at the WS toe. [Additional Reference(s): DWR Levee Log, 1990. USACE Sacramento O&M Manual 121, May 1959, (HLM 0.4) (4-foot by 4-foot concrete culvert listed)]. FS Date: 10/30/2018 1:55:00 PM

Pipe and flap gate with vent riser on WS toe.

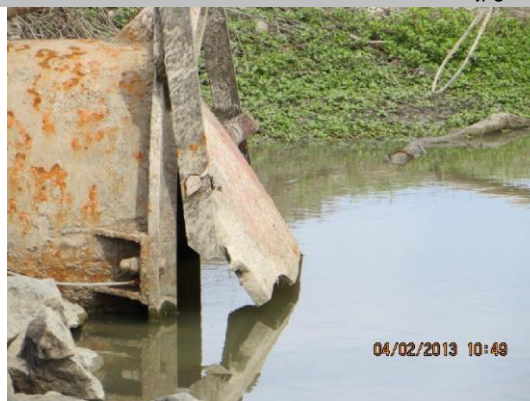
Photo 3 of 3 : UCIP_FA_2018_53429_18200.jpg

Comment Code						
Inspector Comment						
FS_ID:53429 DS_ID:17822 EP_NO: N/A Repair Type: Urgent Crossing Status: Found UCIP Comments: 10/30/2018 Same as last inspection. Flap gate on the WS was submerged at the time of the inspection. Erosion is still present behind the headwall. Sink hole/burrow activity was observed along the concrete box located on the LS. Recommend internal inspection of the pipe section through levee to determine the condition of the pipe through the levee. Crossing remains Urgent due to signs of pipe leakage on LS. (O. Magana - DWR UCIP)09/14/2016 - Flap gate on the WS was submerged at time of inspection. LS headwall at the pumping plant has exposed rebar. There is still erosion present behind the headwall. However, water was present making it difficult to determine if it is getting worse. As-built drawings were requested from LMA consultant representative. (T. Hatch/UCIP)04/02/2013 - Flap gate broken in half on WS toe. Some erosion at headwalls on pumping plant. (W. Wylie/UCIP) FIELD_STRUCT_DESC: 44-inch corrugated metal drainage pipe through the levee, 22 feet below the crown. Pump on platform in drainage ditch at the landside (LS) toe. Slide gate and flap gates in a 5-foot by 9-foot concrete box. Flap gate on the waterside (WS) toe. 8-inch vent/standpipe at the WS toe. [Additional Reference(s): DWR Levee Log, 1990. USACE Sacramento O&M Manual 121, May 1959, (HLM 0.4) (4-foot by 4-foot concrete culvert listed)]. FS Date: 10/30/2018 1:55:00 PM

Broken flap gate at WS toe.

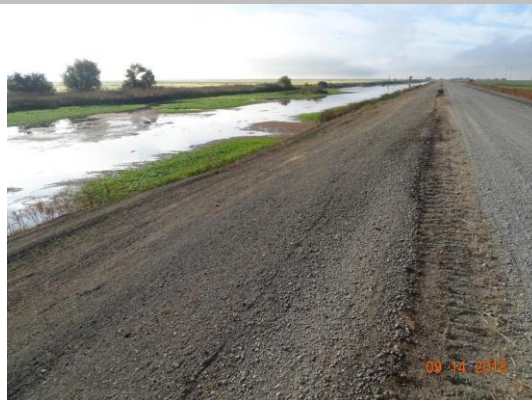
Photo 1 of 1 : FA_2018_RD2035_239_18_20180914_00028.jpg

View of the burned and dragged waterside slope, facing downstream.
Fall 2018.

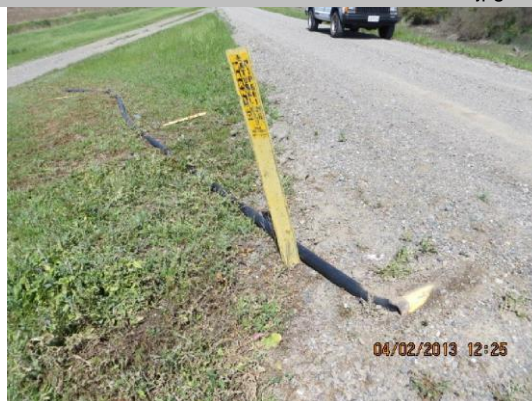
Photo 1 of 3 : UCIP_FA_2018_50090_18922.jpg

Comment Code					
Inspector Comment					
FS_ID:50090 DS_ID:22956 EP_NO: N/A Repair Type: Non-Urgent Crossing Status: Found UCIP Comments: 09/14/2016 - Pipe has been removed from the levee and the levee has been repaired. It is unknown if these repairs were done with a permit or if the fill was properly compacted. Gas line markers still on WS shoulder of levee. It is unknown if another gas line exists in this location. (T. Hatch/UCIP)04/02/2013 - Pipe does not have appropriate cover and is marked as gasoline. Does not appear to be a permitted utility. (W. Wylie/UCIP) FIELD_STRUCT_DESC: *REMOVED* 4-inch steel pipe of an unknown purpose through the levee, 3 inches below the crown. 2-inch polyvinyl chloride (PVC) pipe sleeved through the 4-inch steel pipe. No other appurtenances found. Markers along alignment indicate that the pipe may be a gas line. FS Date: 9/14/2016

Pipe crossing with gasline marker on LS shoulder.

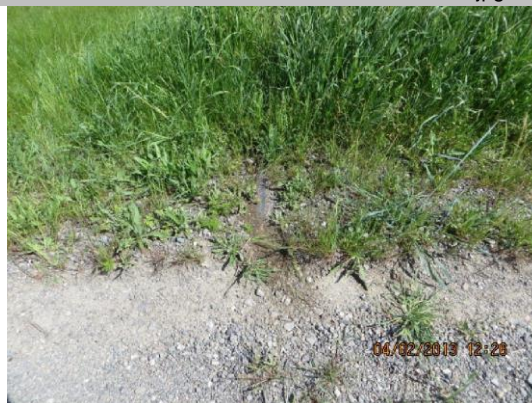
Photo 2 of 3 : UCIP_FA_2018_50090_18921.jpg

Pipe on WS shoulder.

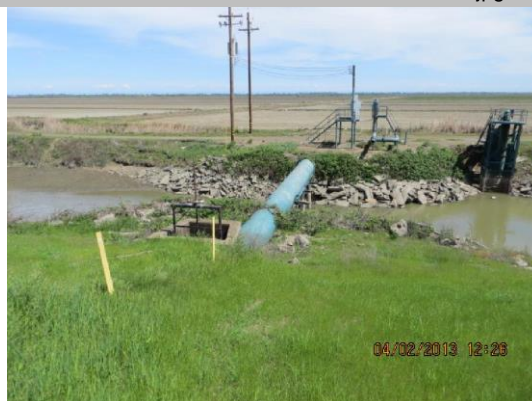
Photo 3 of 3 : UCIP_FA_2018_50090_18920.jpg

Comment Code						
Inspector Comment						
FS_ID:50090 DS_ID:22956 EP_NO: N/A Repair Type: Non-Urgent Crossing Status: Found UCIP Comments: 09/14/2016 - Pipe has been removed from the levee and the levee has been repaired. It is unknown if these repairs were done with a permit or if the fill was properly compacted. Gas line markers still on WS shoulder of levee. It is unknown if another gas line exists in this location. (T. Hatch/UCIP)04/02/2013 - Pipe does not have appropriate cover and is marked as gasoline. Does not appear to be a permitted utility. (W. Wylie/UCIP) FIELD_STRUCT_DESC: *REMOVED* 4-inch steel pipe of an unknown purpose through the levee, 3 inches below the crown. 2-inch polyvinyl chloride (PVC) pipe sleeved through the 4-inch steel pipe. No other appurtenances found. Markers along alignment indicate that the pipe may be a gas line. FS Date: 9/14/2016

Pipe with gasoline markers on WS slope.

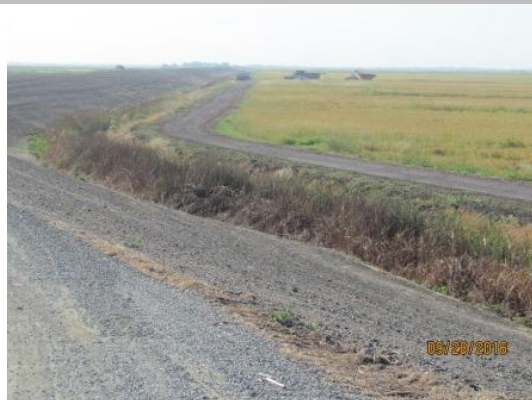
Photo 1 of 1 : FA_2018_RD2035_239_979_20180904_00006.jpg

LM Start	2.18	Rating **	M	Issue No.	979
LM End	4.02	Issue Type +	En	Location *	LS
Category	Earthen Levee			GPS Latitude/Longitude	
				Start	End
Item	Encroachments			38.646063 °	38.623062 °
				-121.666332 °	-121.648925 °
DWR ID	DWR_RD2035_02_s_2012_979				
Comment Code					
DT : Ditch					
Inspector Comment					
Ditch is at the landside toe of the levee.

View of the ditch on the landward side of the levee looking downstream.
Fall 2016 and still exist Fall 2017.

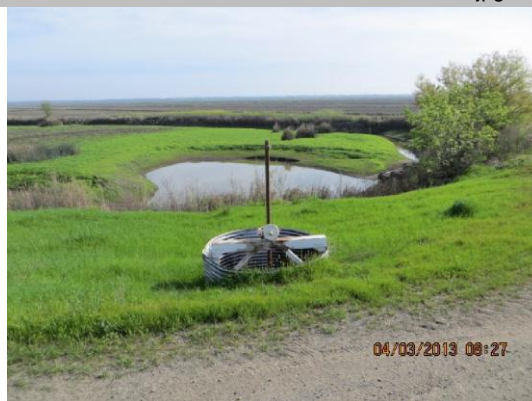
Photo 2 of 3 : UCIP_FA_2018_11526_18934.jpg

Comment Code						
Inspector Comment						
FS_ID:11526 DS_ID:17828 EP_NO: 1701 Repair Type: Non-Urgent Crossing Status: Found UCIP Comments: 04/03/2013 Animal activity at outlet causing damage to berm and undermining the pipe at the outlet headwall on WS toe. (W. Wylie - DWR UCIP) FIELD_STRUCT_DESC: 60-inch corrugated metal drainage pipe encased in 6 inches of reinforced concrete through the levee, 20.6 feet below the crown. Slide gate in a 7-foot-diameter corrugated metal pipe (CMP) riser on the waterside (WS) slope. Pumping plant with 6 pumps and pipes that discharge into a 4-foot by 18-foot surge box on the landside (LS) toe. (Permit No. 1701, 1952 - Reclamation District No. 2035). [Additional Reference(s): DWR Levee Log, 1990. USACE Sacramento O&M Manual 121, May 1959, (HLM 4.7)]. FS Date: 4/3/2013

7-foot diameter CMP riser and slide gate on WS slope.

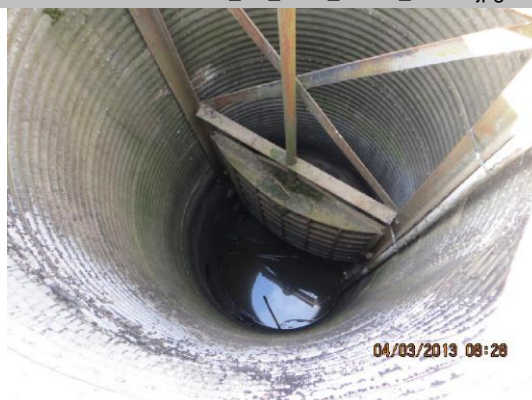
Photo 3 of 3 : UCIP_FA_2018_11526_18933.jpg

7-foot diameter CMP riser and slide gate on WS slope.

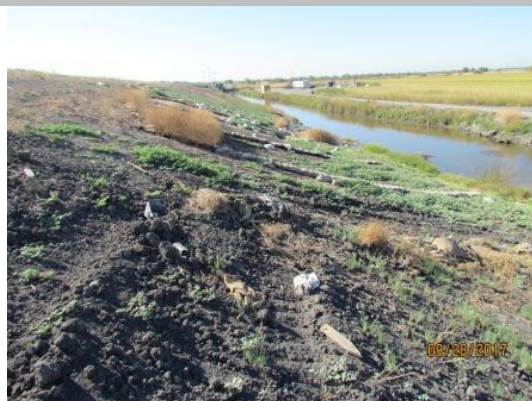
Photo 1 of 4 : FA_2018_RD2035_239_31_20180904_00002.jpg

LM Start	6.35	Rating **	A/W	Issue No.	31	
LM End	6.38	Issue Type +	Ma	Location *	LS	
Category	Supplemental			GPS Latitude/Longitude		
				Start	End	
Item	2017 Storm Damage			38.592840°	38.592390°	
				-121.631340°	-121.631320°	
DWR ID	DWR_RD2035_02_f_2017_31					
Comment Code						
Inspector Comment						
Levee Evaluation Comments						
Description:						
Site ID No:195						
Site Designation:RD 2035-08						
Repair Type: Erosion						
Rating:Critical						
Field Date:7/13/2017						
Notes: long longitudinal cracks on the crown. Scheduled for repair 2019.

View looking downstream landside of 2017 Storm Damage, sluffing site. All plastic is remove, sandbags remain, and is NOT scheduled to be repaired in 2017.

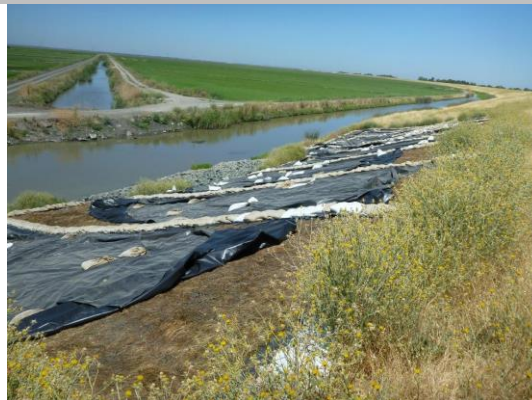
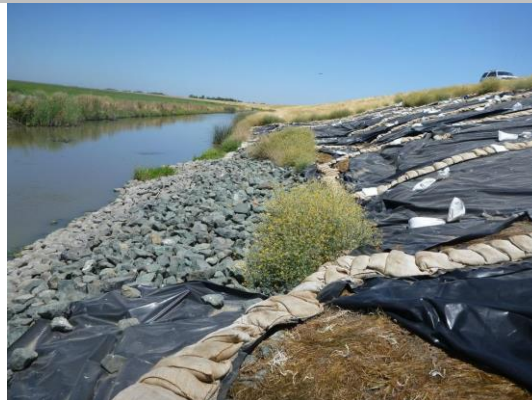
LM Start	6.35	Rating **	A/W	Issue No.	31 (cont)	
LM End	6.38	Issue Type +	Ma	Location *	LS	
Category	Supplemental			GPS Latitude/Longitude		
				Start	End	
Item	2017 Storm Damage			38.592840 °	38.592390 °	
				-121.631340 °	-121.631320 °	
DWR ID	DWR_RD2035_02_f_2017_31					
Comment Code						
Inspector Comment						
Levee Evaluation Comments						
Description:						
Site ID No:195						
Site Designation:RD 2035-08						
Repair Type: Erosion						
Rating:Critical						
Field Date:7/13/2017						
Notes: long longitudinal cracks on the crown. Scheduled for repair 2019.

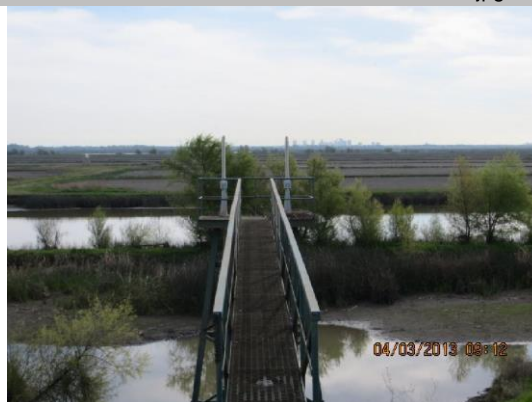
Photo 1 of 3 : UCIP_FA_2018_50089_18327.jpg

Comment Code						
Inspector Comment						
FS_ID:50089 DS_ID:17868 EP_NO: 16480 Repair Type: Non-Urgent Crossing Status: Found UCIP Comments: 09/14/2016 - Erosion on the LS toe at the sheet pile walls for the pumping plant is still present. It does not appear to be significantly different than during the previous inspection. Erosion should be monitored, but at this time does not appear to result in a potential threat to levee integrity. (T. Hatch/UCIP)04/03/2013 - Erosion on LS toe at pumping plant. Severe erosion of sheet pile walls at pumping plant. (W. Wylie/UCIP) FIELD_STRUCT_DESC: 1 of 2: 60-inch by 48-inch reinforced concrete box drainage culvert through the levee, 22 feet below the crown. Steel walkway to the slide gate handles on the waterside (WS) shoulder. 6-foot by 18-foot surge box and pumping plant on the landside (LS) toe. This culvert replaced a 48-inch at the same location. (Permit No. 16480, 1995 - Conaway Conservancy Group and Reclamation District No. 2035). FS Date: 9/14/2016

Steel walkway to slide gates on WS shoulder.

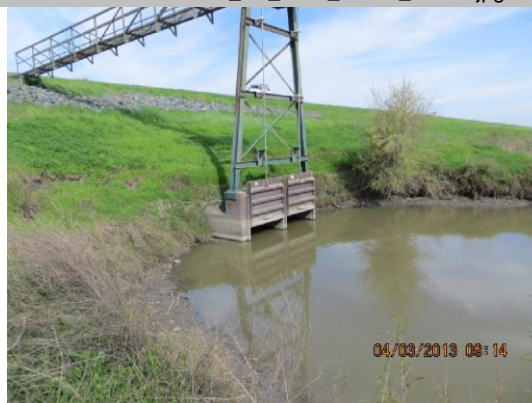
Photo 3 of 3 : UCIP_FA_2018_50089_18325.jpg

Slide gates at WS toe.

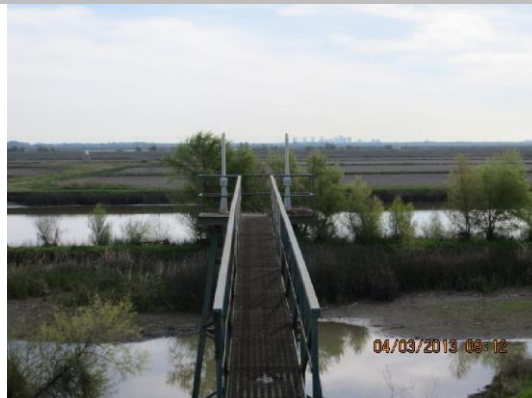
Photo 1 of 3 : UCIP_FA_2018_50088_18321.jpg

Steel walkway to Slide gate handles on WS shoulder.

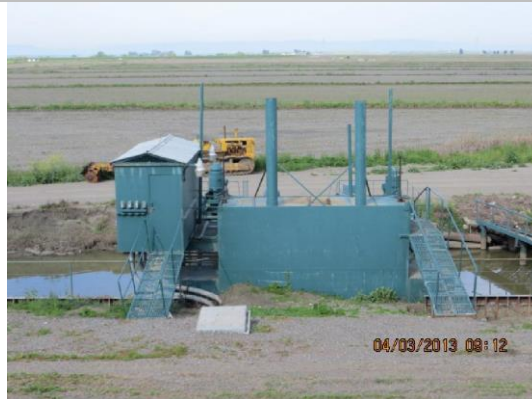
Photo 2 of 3 : UCIP_FA_2018_50088_18320.jpg

Surge box and pumping plant on LS toe.

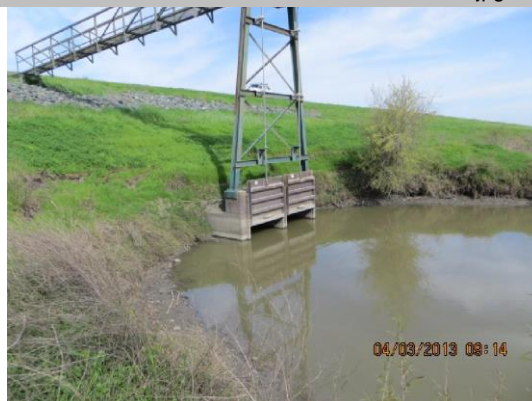
Photo 3 of 3 : UCIP_FA_2018_50088_18319.jpg

Slide gates at outlet on WS toe.

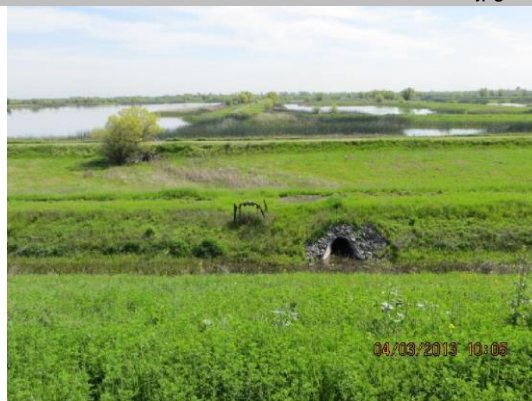
Photo 1 of 3 : UCIP_FA_2018_53430_18345.jpg

Gasline vent off LS toe.

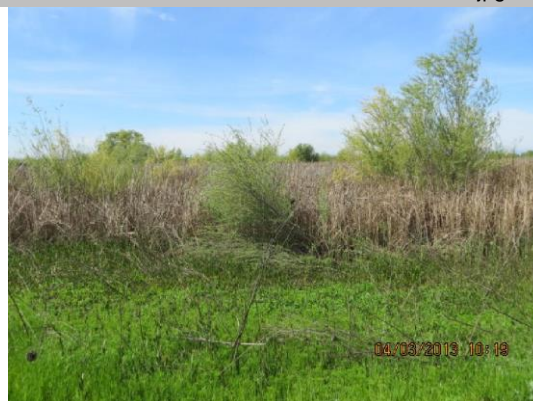
Photo 3 of 3 : UCIP_FA_2018_41128_18346.jpg

Vegetated area blocks access to WS of pipe.

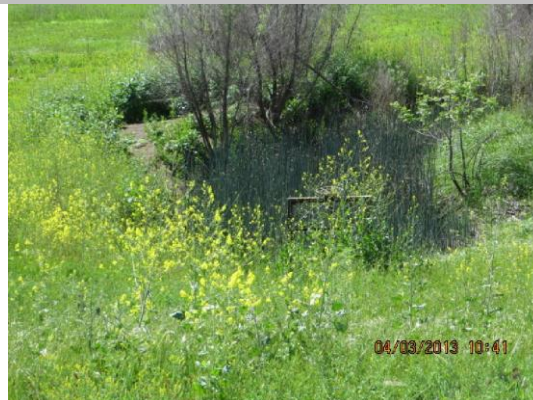
Photo 1 of 2 : UCIP_FA_2018_11011_18354.jpg

Slide gate at WS toe showing excessive vegetation.

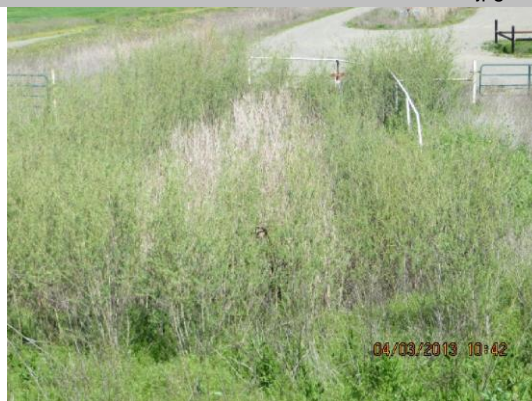
Photo 2 of 2 : UCIP_FA_2018_11011_18353.jpg

Slide gate at LS toe showing excessive vegetation.

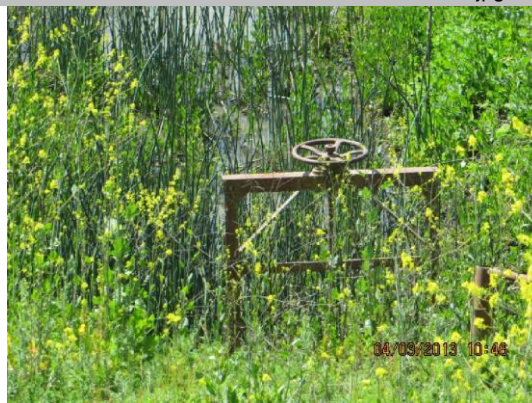
Photo 1 of 3 : UCIP_FA_2018_11012_18357.jpg

Combination flap and slide gate on WS toe. With excessive vegetation

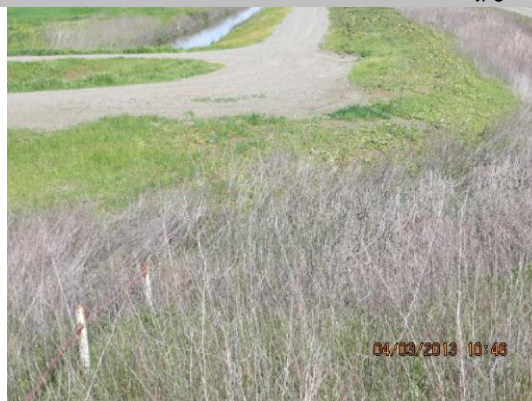
Photo 2 of 3 : UCIP_FA_2018_11012_18356.jpg

Headwall at bottom of fenceline on LS to.e

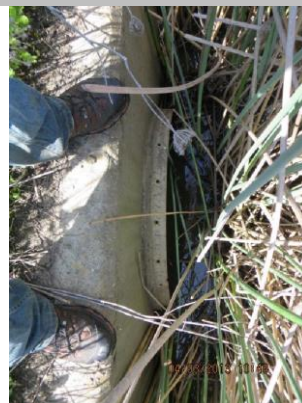
Photo 3 of 3 : UCIP_FA_2018_11012_18355.jpg

Headwall and pipe on LS toe.

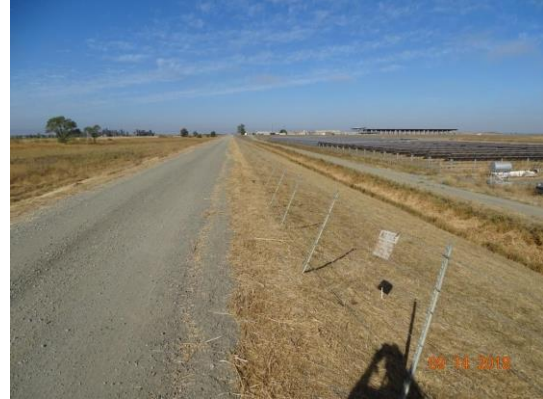
Photo 1 of 2 : FA_2018_RD2035_240_5_20180914_00014.jpg

Updated view of fence on the landside shoulder of the crown. Fall 2018.

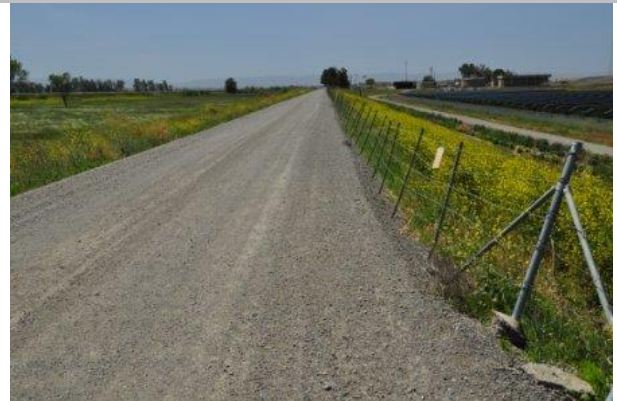
Photo 2 of 2 : FA_2018_RD2035_240_5_20180904_00001.jpg

Fence along the landside shoulder of the crown belongs to the treatment plant and has not changed from previous inspections, Fall 2017.
